NATIONAL TRANSPORTATION SAFETY BOARD

TRANSPORTATION SAFETY RECOMMENDATIONS

ADOPTED DURING THE MONTH
OF MARCH, 1998

In reply refer to: A-98-9 through -23

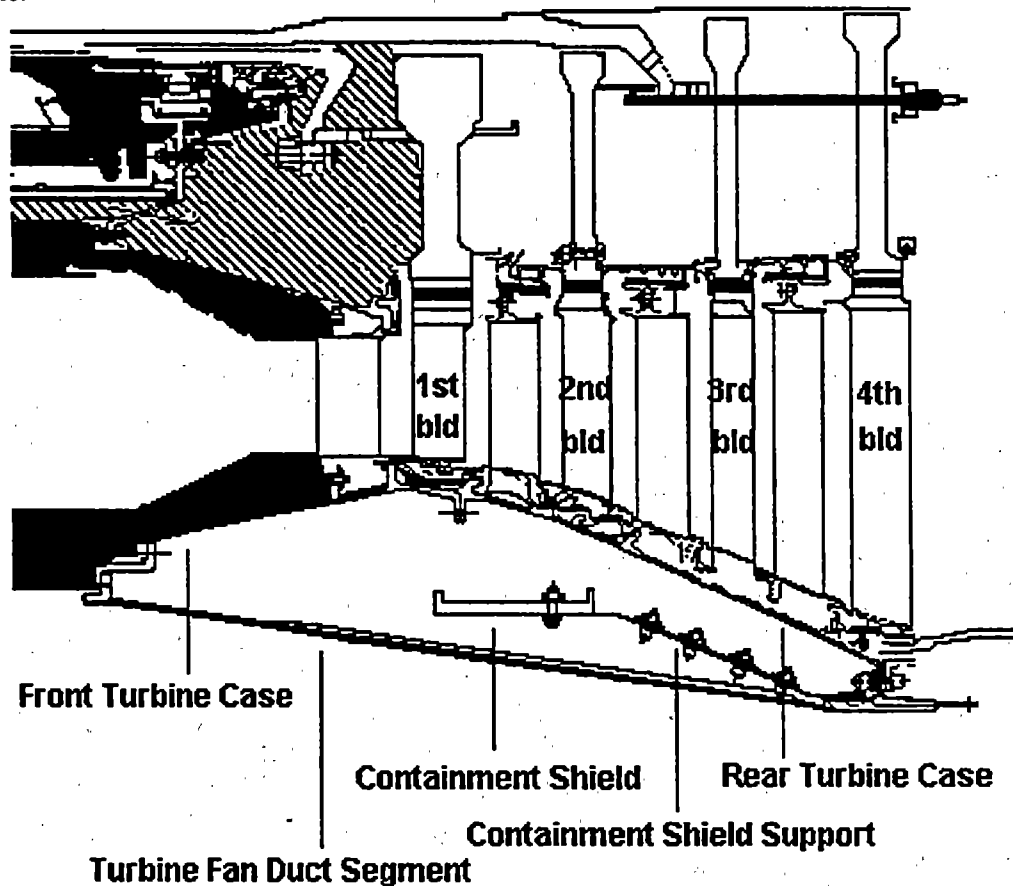
¹ The containment shield is intended to prevent engine HPT parts from being liberated and causing secondary damage to the airplane or injuring passengers. The shield is positioned radially outward from the rotational plane of the HPT blades. The width of the containment shield is approximately 4 inches, and its support attaches to the HPT case rear flange. The support, although it provides some containment capability, is primarily to buttress and properly position the containment shield.

applicable to all JT8D-209, -217, -217A, -217C, and -219 turbofan engines. The containment shield is a clam shell design consisting of two half-shields joined by clevis plates and supported by a cantilevered shield support attached to the HPT rear flange. Considerable impact damage (engine debris) was observed on the inner diameter (ID) of the containment shield; however, the shield remained intact. The impact of turbine material on the lower shield shifted it outward and aft from its normal installed position, buckling its support. First-stage turbine blades and 2nd-stage turbine vanes had exited the engine through the openings between the HPT and LPT case flanges and deflected off the containment shield ID while exiting the engine and before striking the airframe.

Figure 1 Containment Shield Configuration
